**TO:** All Mazda Dealership General Managers, Service Managers, and Parts Managers

**DATE:** March 2007

**SUBJECT:** 2005 Tribute Headliner Compliance Recall 4006D – **RENOTIFICATION**

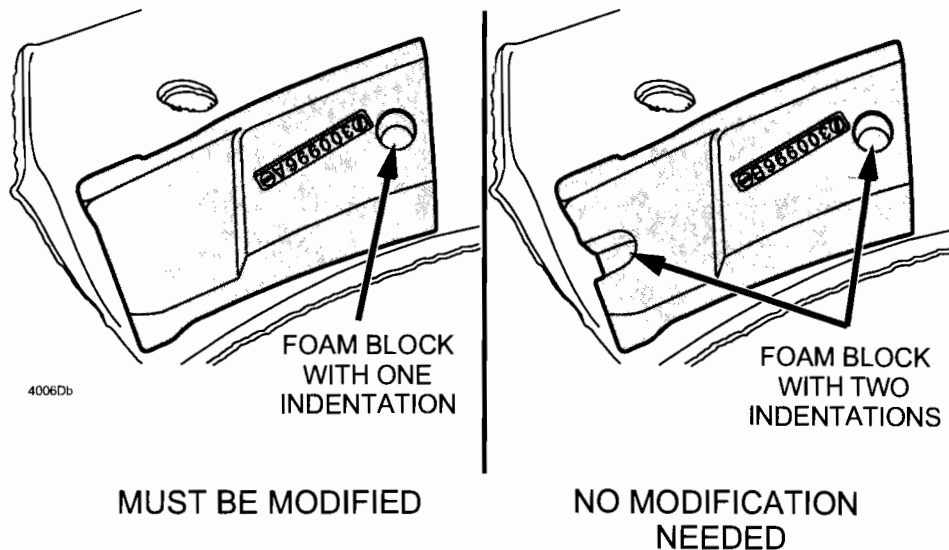
1. Without pulling the headliner down beyond its natural hanging rest position, carefully inspect the structural foam blocks mounted at the passenger and drivers side front corners on the top of the headliner to see if they have one (1) or two (2) indentations.

- If the blocks have two (2) indentations, no modification is required. Proceed to ASSEMBLY.
- If the blocks have only one (1) indentation, proceed to DISASSEMBLY FOR MODIFICATION.
